Larkspur Landing - Marriott's Hotel

By Wes Bender

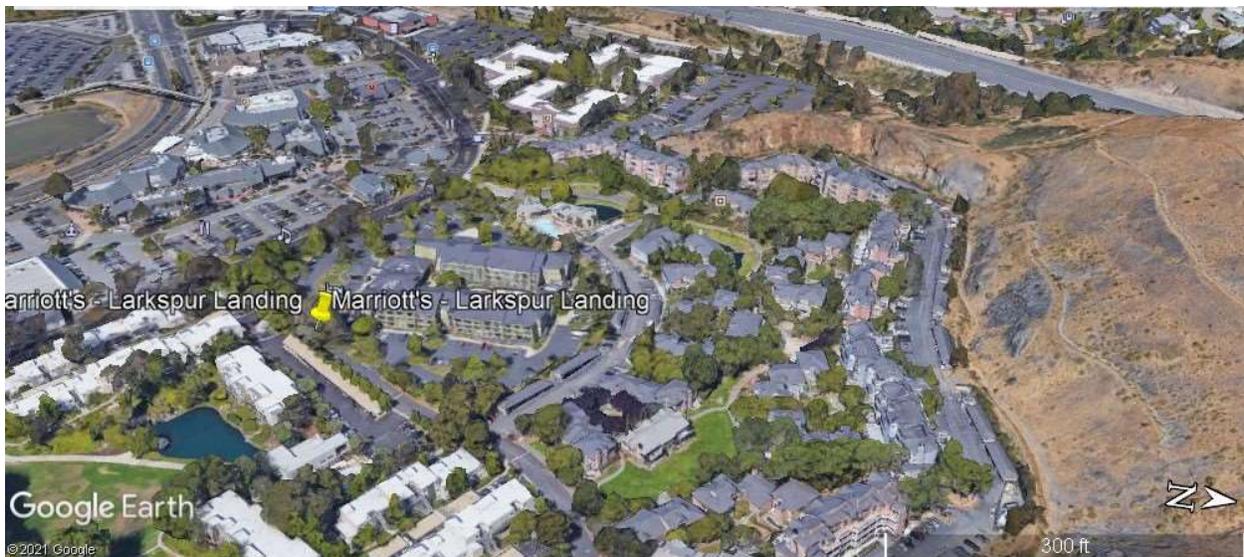
Larkspur Landing site as it appears today (courtesy of Google Earth).

Marriot's Hotel in center. White buildings in lower left are the apartments.
